Manhole Inspection Summary

Manhole # S13OO1005MH

Insp Date: **11/29/06 9:50 AM**

Location Address: **2716 WOODLAND AVE**

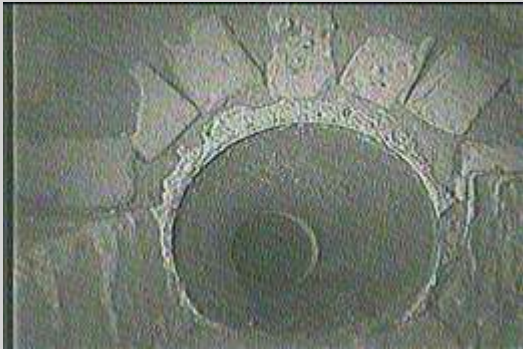
8 in. Circular Gravity Sewer Pipe Out @ 12 O'Clock

Pipe Material: **Clay** ☐ Pipe Lined

Infiltration: **None** Pipe Seal Cond: **Unknown**
